Water Pump Catalog

2022

Yamada Manufacturing Co., Ltd.

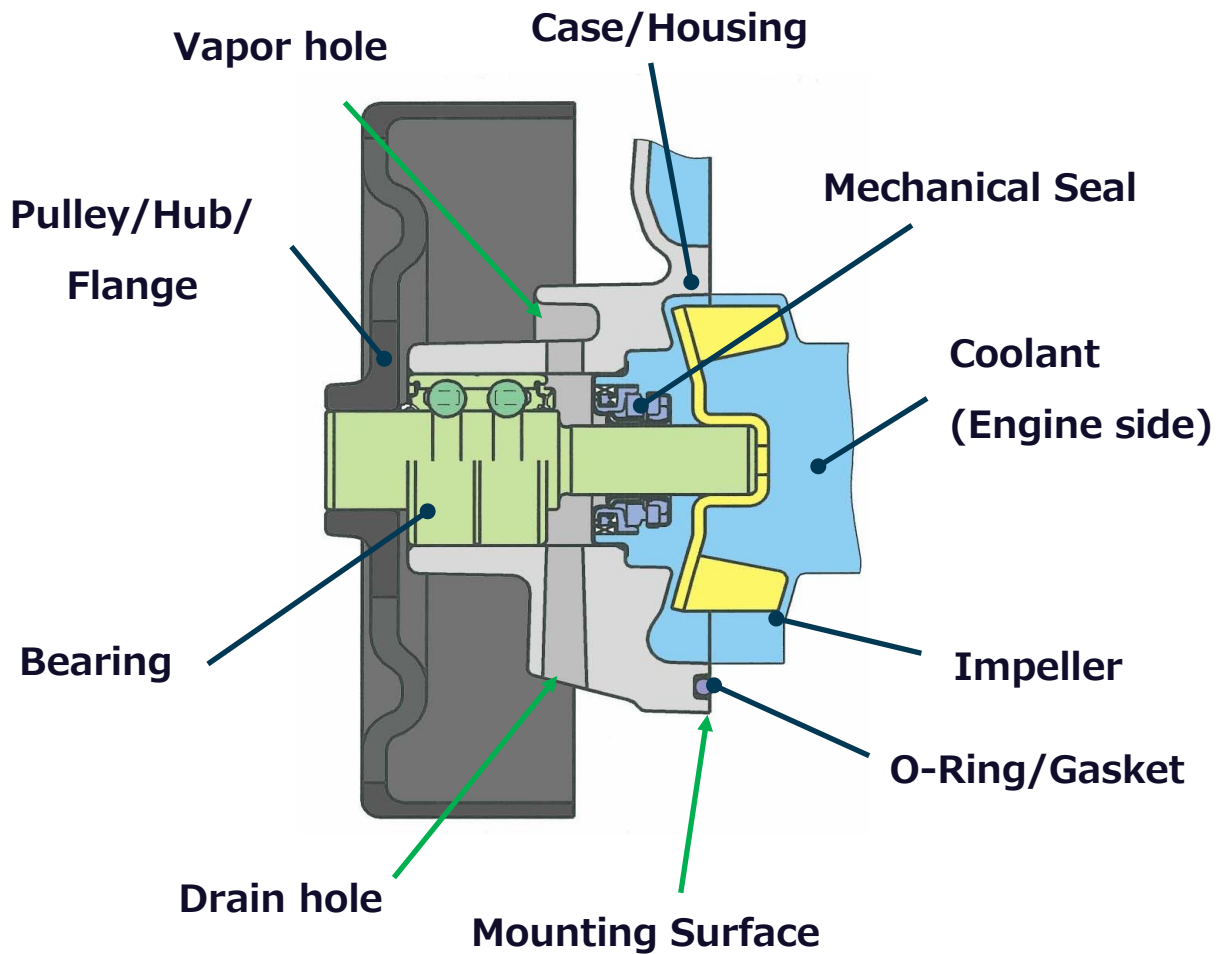
I . Structure and Components

Water pump is playing a role to maintain an appropriate temperature as to synchronize rotation of an engine and then transmit power to support belt for a circulation of coolant. Mechanical seal is a part that stop preventing coolant leak, and it is well structured as to shut with a minute liquid film developing its components between rotation ring and rigid ring. Drain hole discharges coolant and contamination coming out from a tiny gap on mechanical seal. Steam hole protects bearing by discharging coolant turning out to become high temperature steam. Bearings are designed to endure tension of support belt and to keep maintaining smooth rotations.

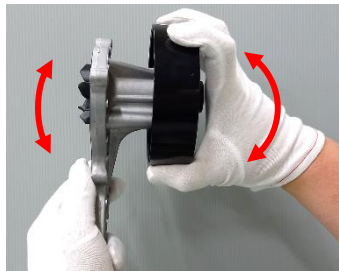
1. Prohibit dry running

Triger water leak if surface of both rotation ring and rigid ring inside of mechanical seal runnning without having coolant.

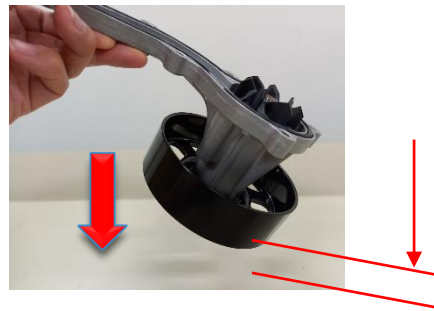
2. Do not drop

Lead to a damage of bearing dropping from very slight height though.

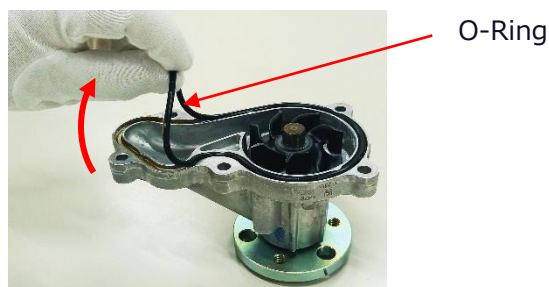
3. Do not remove O-Ring/Gasket

Do not remove a O-Ring/Gasket being attached on a case and just directly assemble it to an engine. Cause water leak if re-attached.

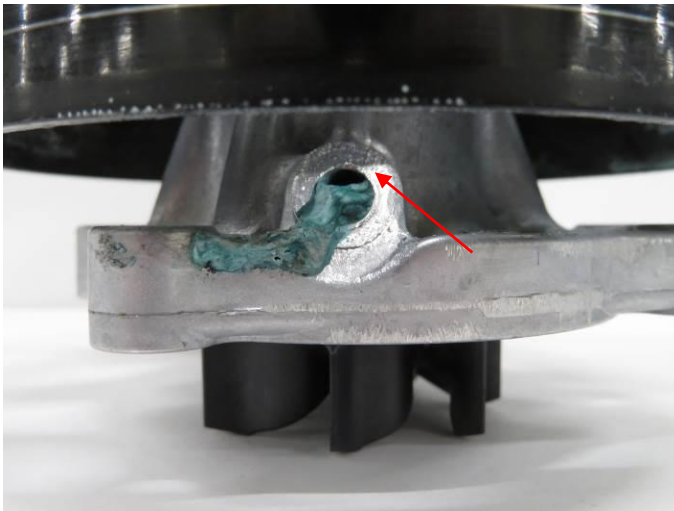
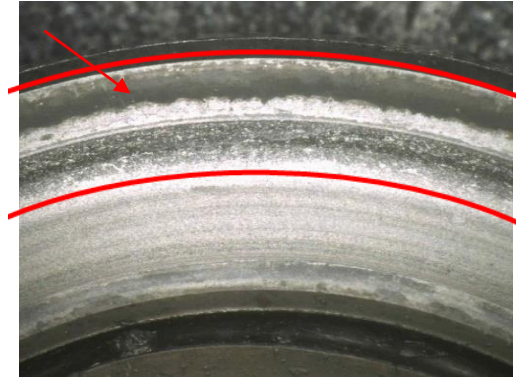
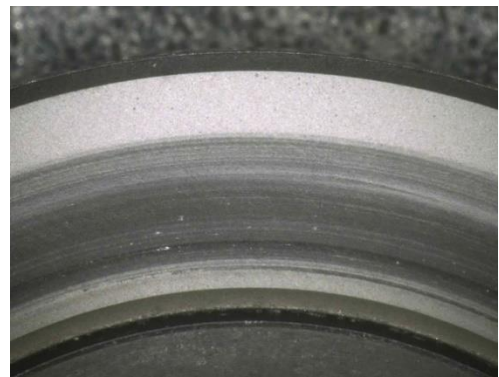
Leakage : Mechanical Seal Ring damaged

Abnormal

Normal

Damage sliding surface of both rotation ring and rigid ring on mechanical seal caused by use of deteriorated coolant. As a result, lead water leak.

- ✓ Clean mounting surfaces of interior engine and pump at a replacement of coolant (clean mounting surface without leaving any contamination).
- ✓ Prohibit re-use of coolant
- ✓ Prohibit use of liquid gasket (staying in coolant turns out to become contamination).

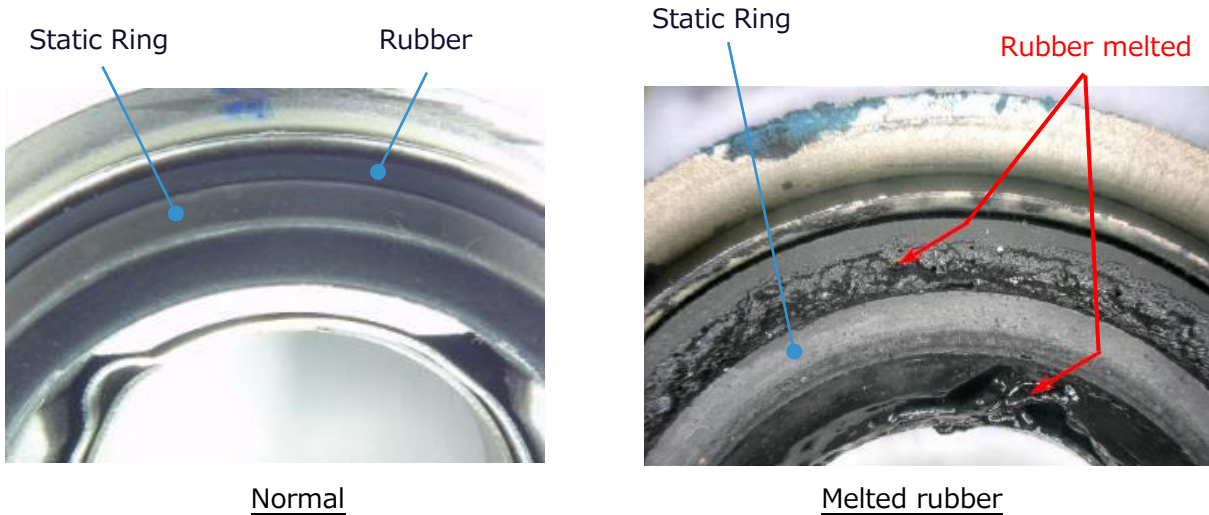
Leakage : Mechanical Seal Rubber melted

Abnormal heat happens not enough cooling from long hours of dry running (No or not enough coolant). Lead water leak from melted rubber inside of mechanical seal.

- ✓ Fulfill cooling water with the specified amount (ensure to perform air bleeding)
- ✓ Prohibit reuse of coolant
- ✓ Prohibit to use low concentration coolant

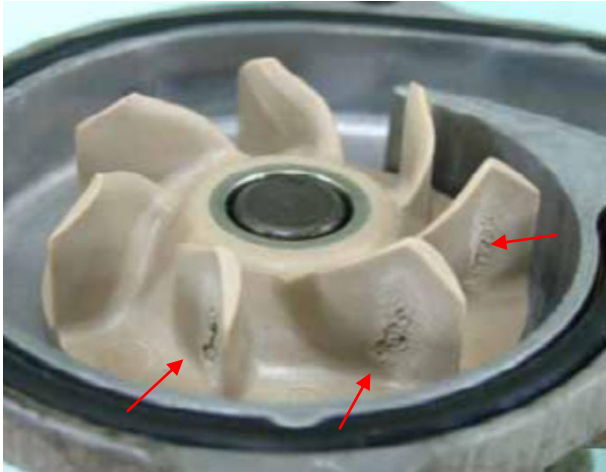
Impeller : Cavitation

Generate cavitation using deteriorated coolant. As to progressively accelerate cavitation, unable to circulate coolant due to damage of impeller will lead to overheat. Also as to progress cavitation on CASE, consequently to make holes on CASE and high temperature cooling water running outside to cause a critical condition.

- ✓ Fulfill cooling water with the specified amount (ensure to perform air bleeding)
- ✓ Prohibit reuse of coolant
- ✓ Prohibit to use low concentration coolant
- ✓ Prohibit any modifications not recommended by automotive makers.

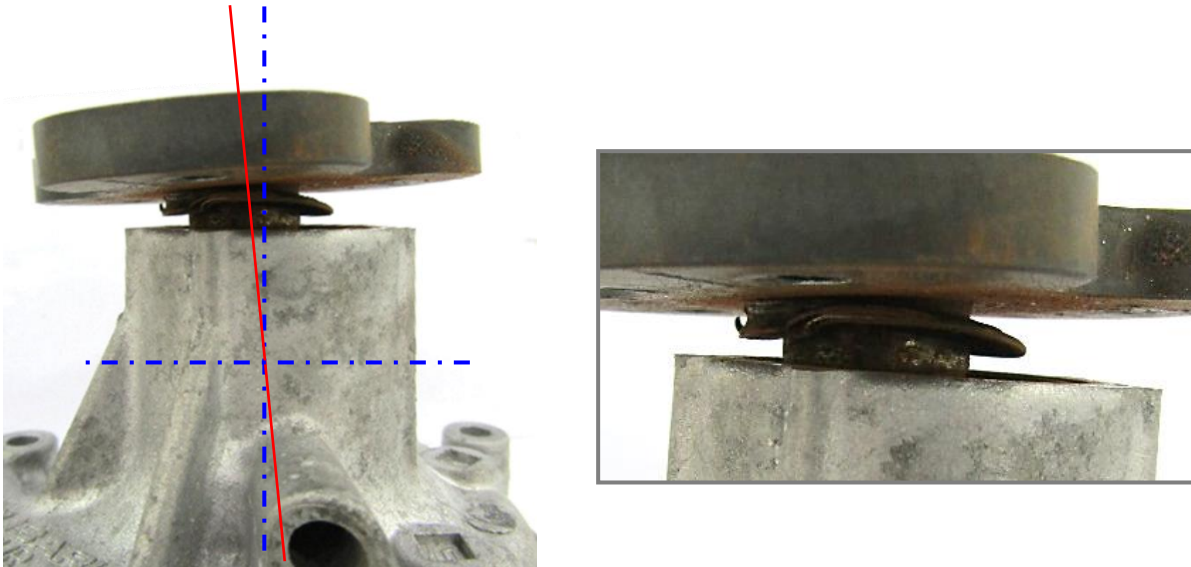
Abnormal : Bearing damaged

Damaged bearing

As the end result of using repeatedly fallen water pump, dent of its bearing getting expanded and bearing gets damaged, happens abnormal noise from large runout, support belt comes off and cannot cool down leading to overheat.

- ✓ Do not drop water pump
- ✓ Do not hit pulley and flange with hammer etc. to give any shock.
